TECHNICAL REPORT REMR-CO-3

CASE HISTORIES OF CORPS BREAKWATER AND JETTY STRUCTURES

Report 3
NORTH CENTRAL DIVISION

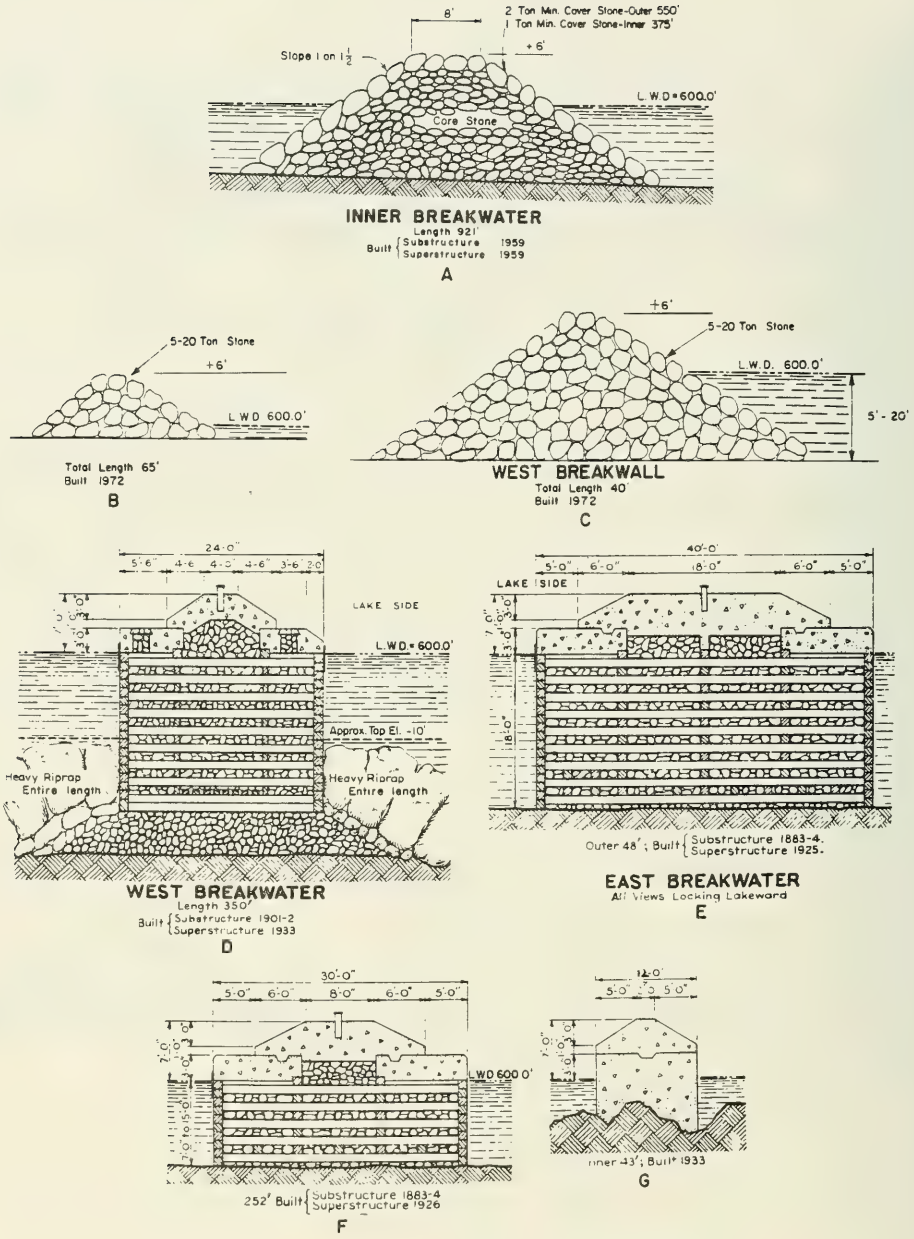
Figure 6. Typical breakwater cross sections, Grand Marais Harbor, Minnesota

Date(s)	Construction and Rehabilitation History
	additional stone to raise the el in some locations above the water level. The concrete cap of the west breakwater was noted shifting, cracking, separating, and/or tilting in some locations. Concrete spalling also was noted.
1986	The general condition of the east and west breakwaters is considered fair. The rubble-mound inner breakwater is in good condition.

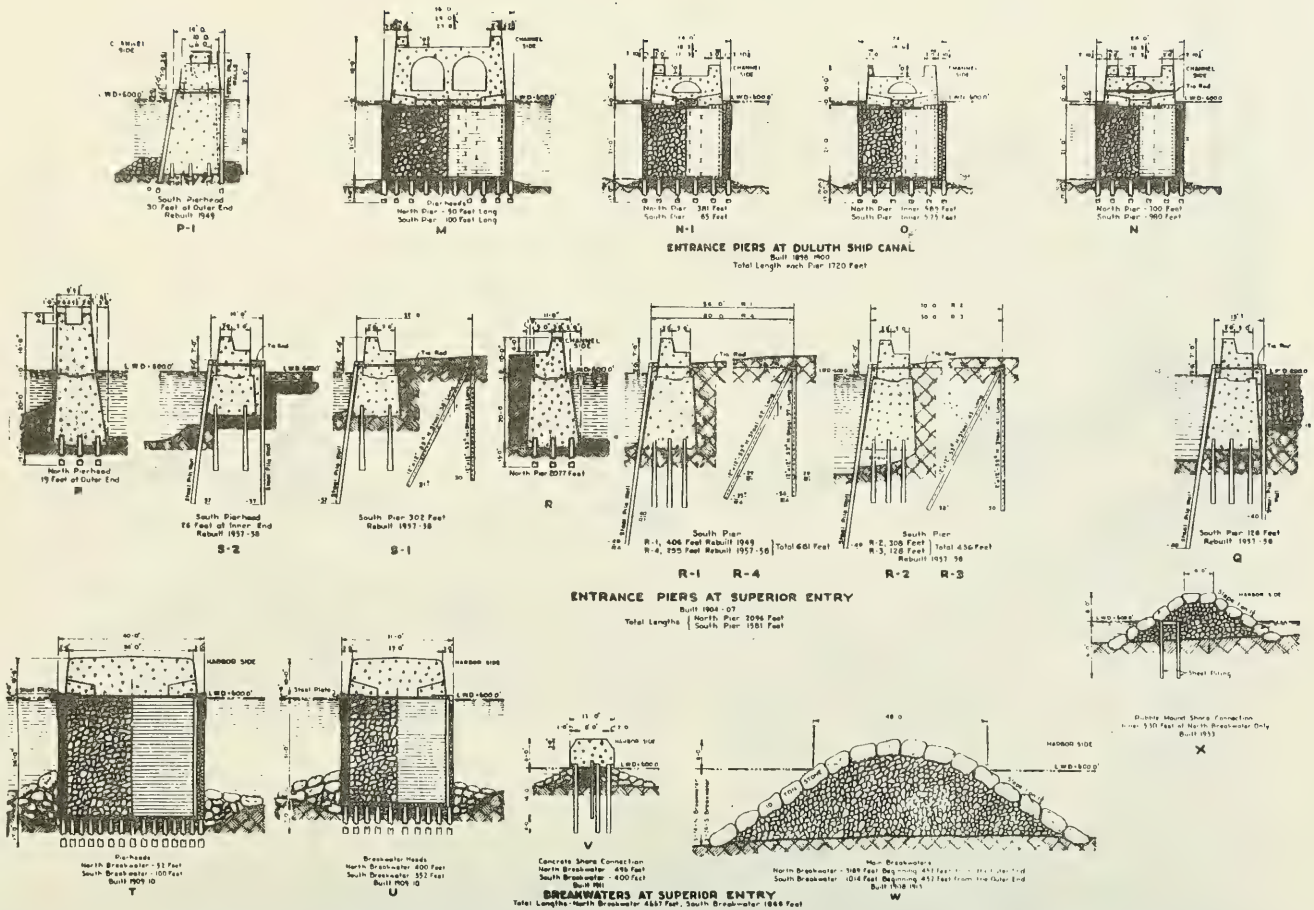
Figure 12. Typical pier cross sections, Duluth-Superior, Minnesota and Wisconsin

1986	In general, very little maintenance has been needed since construction of the project. Minor patching of spalling concrete has been attempted with generally poor results. The structures overall are presently in fair condition.

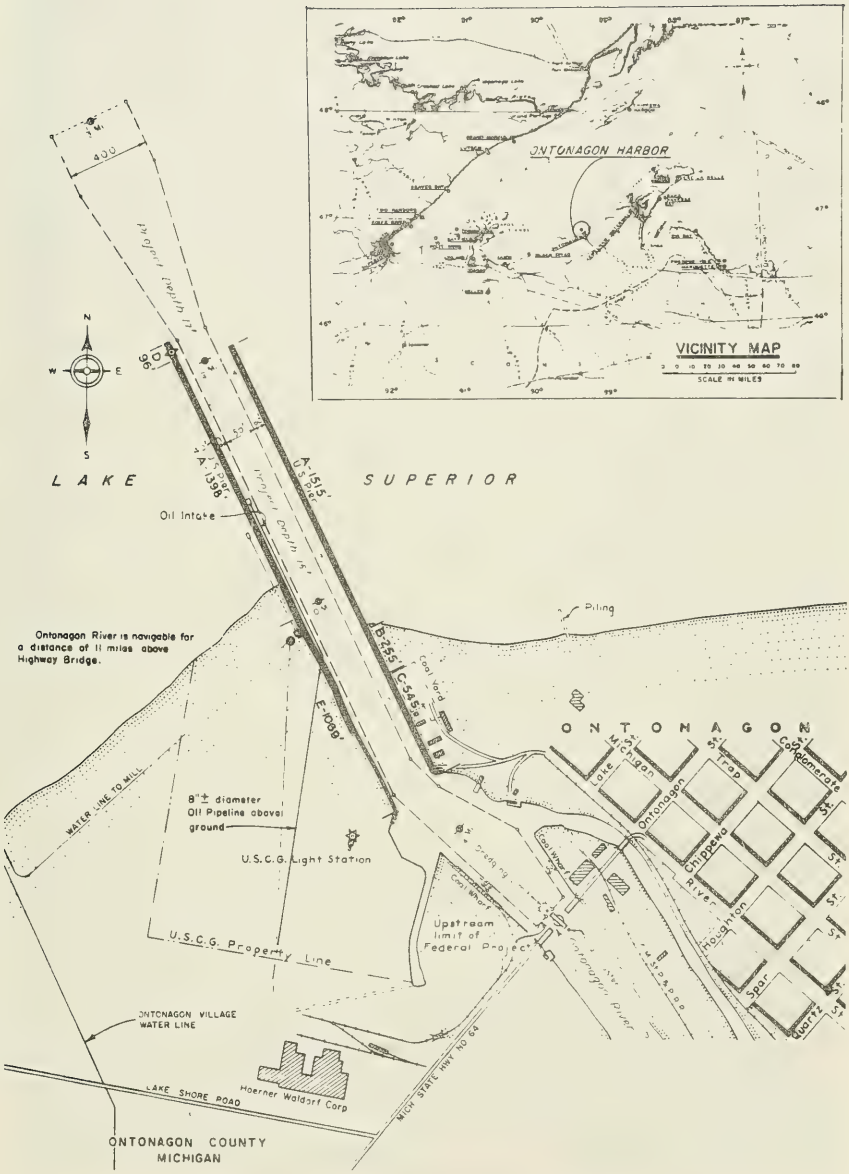
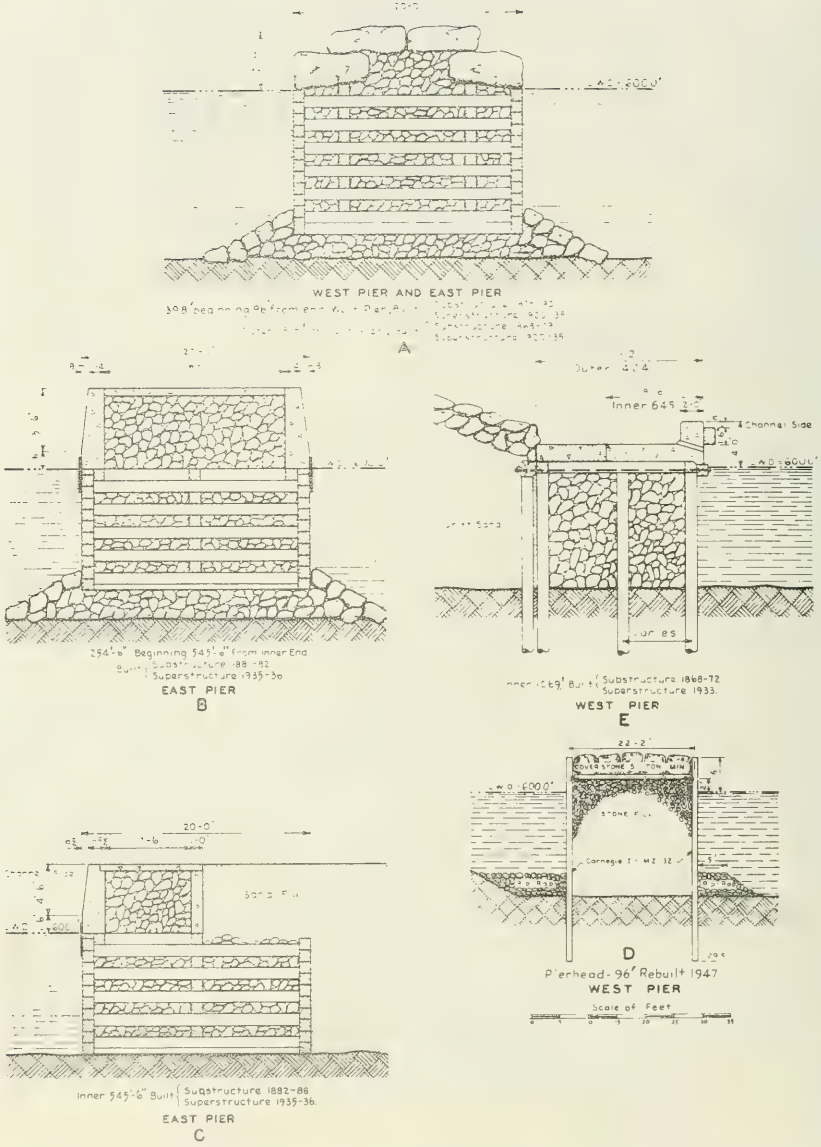
Figure 28. Ontonagon Harbor, Michigan

1920-1935	A stone superstructure was built on 1,515 and 1,398 ft of the east and west piers, respectively (Figure 29, Section A). The el of these piers was +5 ft lwd.
1933	A concrete cap (superstructure) was constructed on the inner 1,069 ft of the west pier (Figure 29, Section E). The el of the channel side of the pier was +4 ft lwd.
1935-1936	A stone and concrete cap (superstructure) was installed on 800 ft of the east pier (Figure 29, Sections B and C). The shoreward 545 ft of structure had a crest el of +5 ft lwd (Section C), while the remaining pier had an el of +6 ft lwd (Section B).
1947	The 96-ft-long west pierhead was rebuilt with steel sheetpiling that was stone filled. It was capped with 5-ton minimum cover stone. The pierhead was 22 ft wide with a crest el of +6 ft lwd. Riprap was installed to provide toe protection. It is not clear when the pierhead was originally constructed.
1983	A structural inspection of the piers was made. A void up to 20 ft wide was observed on the west pier, and sand was being lost through the cribbing under the superstructure. Additional stone was required

Date(s)	Construction and Rehabilitation History
	at various locations on both piers, and it was noted that the concrete superstructure had spalled in areas. In the summer of this year, core and cover stone were placed where necessary to repair the structures.
1986	The piers presently are in fair condition. An aerial view of Ontonagon Harbor piers is shown in Figure 30.

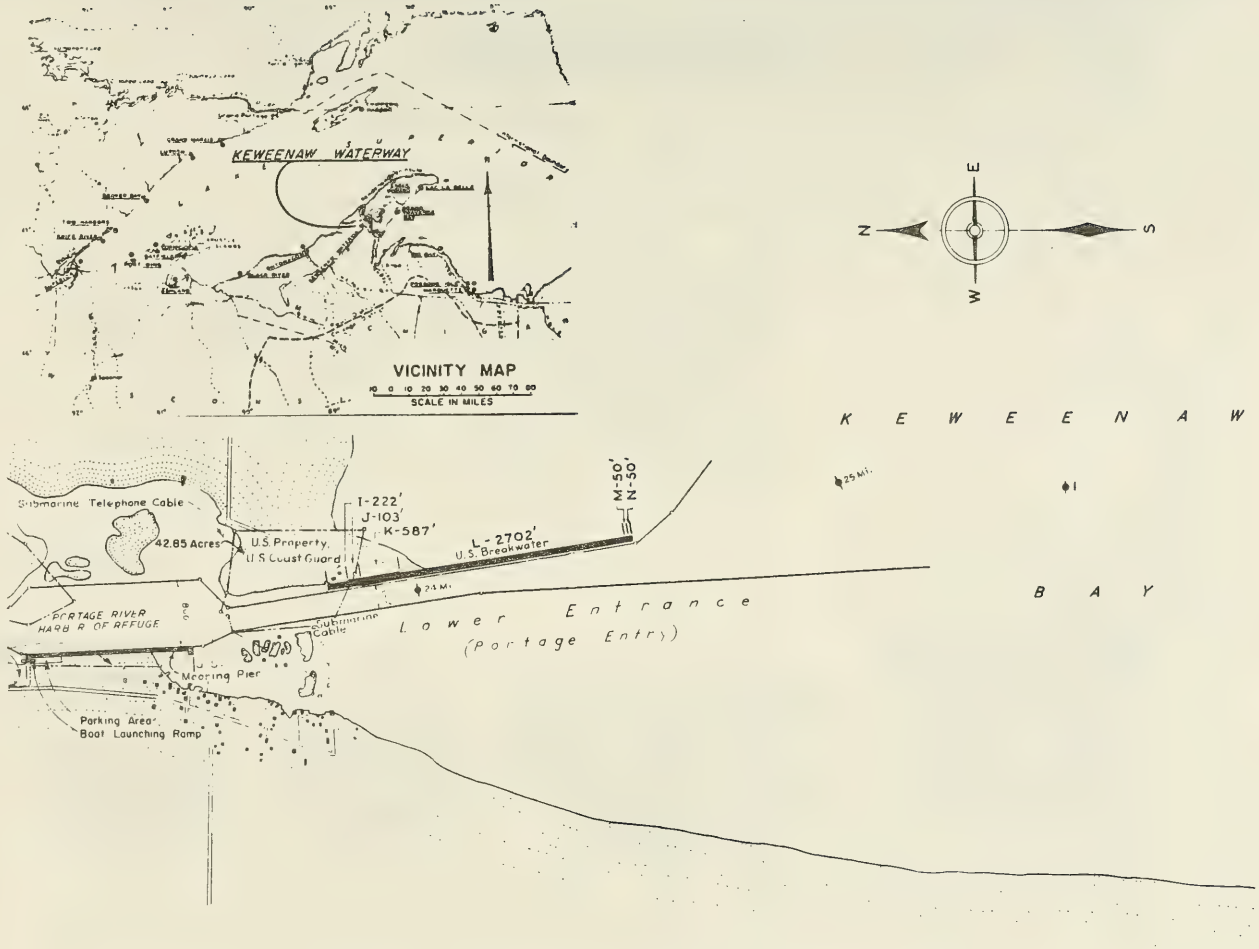
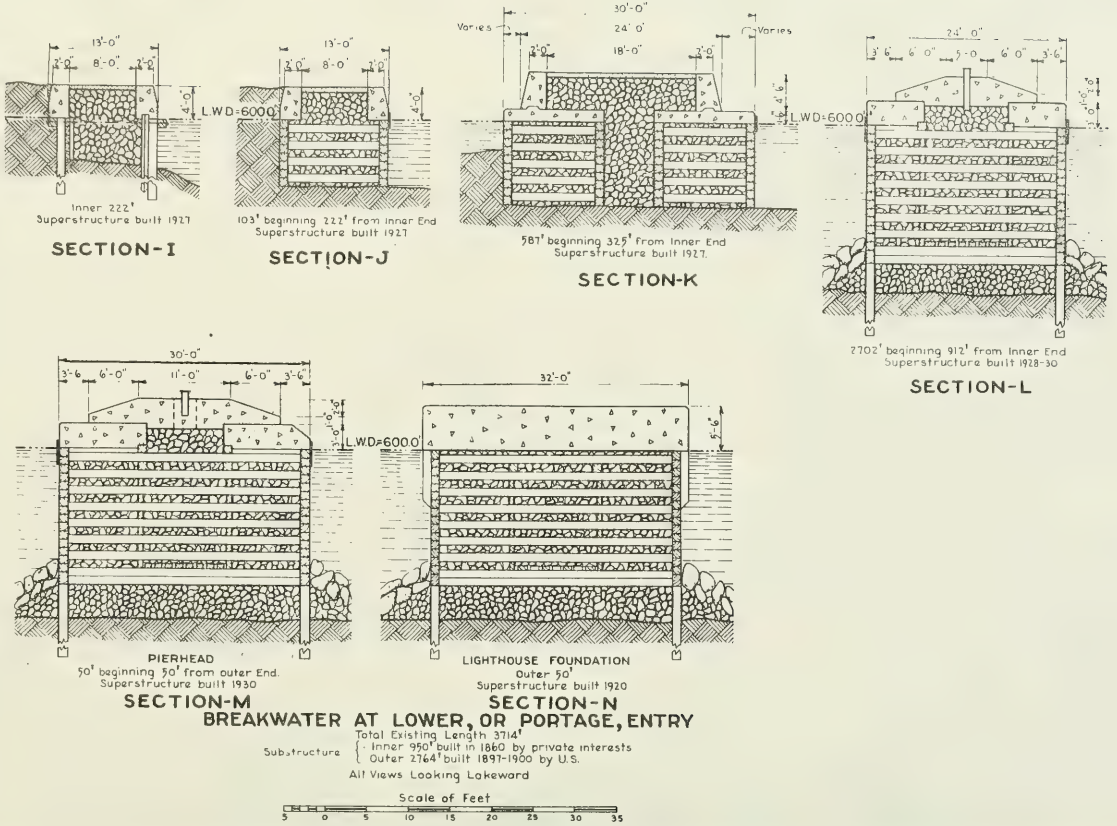
Figure 34. Lower entrance, Keweenaw Waterway, Michigan

Date(s)	Construction and Rehabilitation History
	South (Lower) Entry
1920	The outer 50 ft of the breakwater was capped with concrete (Figures 34 and 35, Section N). The crest el of the cap was +5.5 ft lwd, and it was 32 ft in width.
1927	The shoreward 912 ft of the structure was capped with stone and concrete (Figures 34 and 35, Sections I-K). The crest of the shoreward 325 ft of breakwater was built at an el of +4.0 ft lwd with the remaining 587 ft installed at an el of +4.5 ft lwd.
1928-1930	During this period a 2,702-ft-long section of the breakwater was capped with stone and concrete (Figures 34 and 35, Section L). A crest el of +6 ft lwd was constructed.
1930	The superstructure of the 50-ft-long pierhead was completed (Figures 34 and 35, Section M). Concrete and stone were used for construction with a crest height of +6 ft lwd installed.
1983	An inspection of the Lower Entry breakwater indicated the structure was stable and generally in good condition. Extreme spalling of the concrete had taken place in some areas, however, and some areas of the breakwater were in need of additional stone fill.

1986	The breakwater at the Lower Entry presently is in fair to good condition.

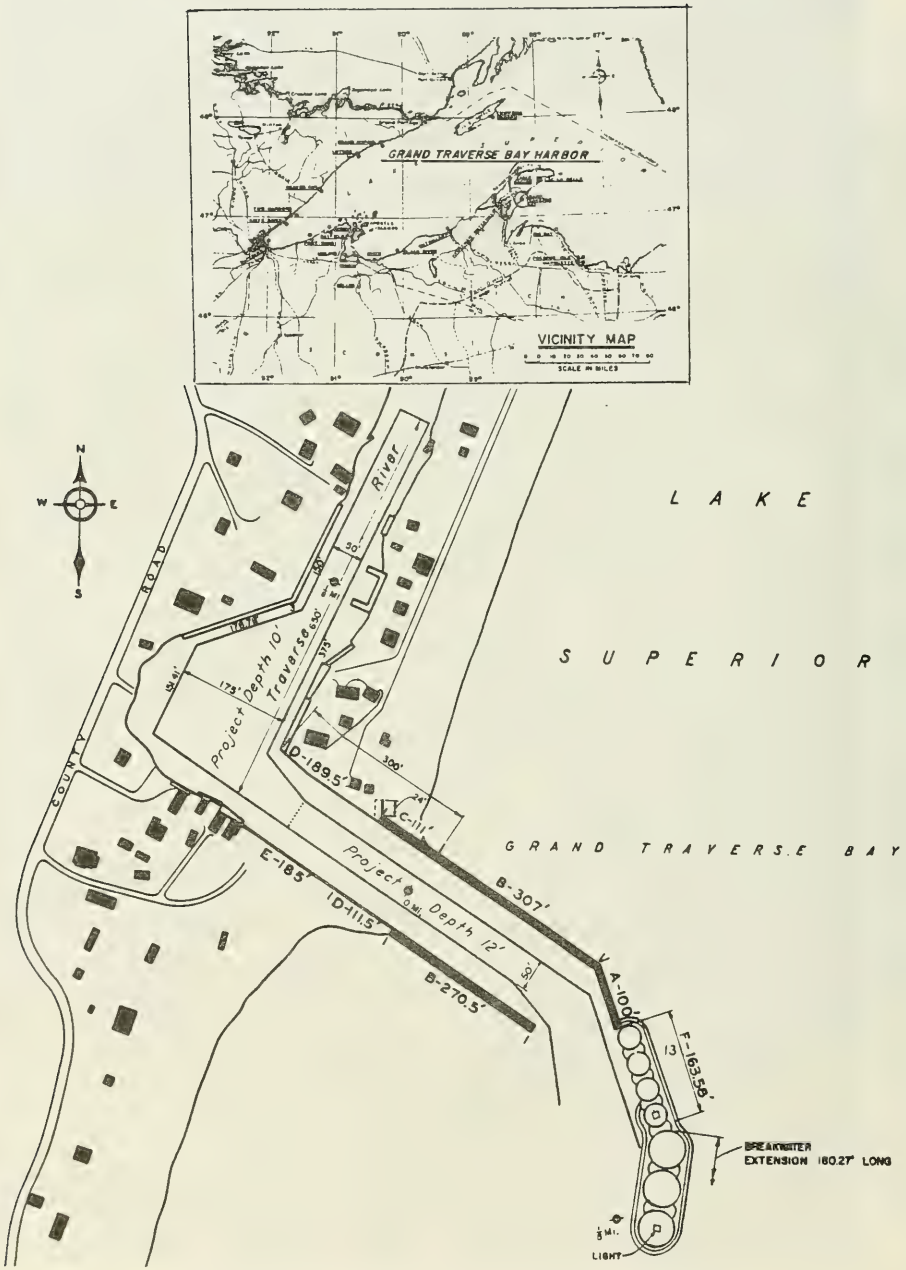
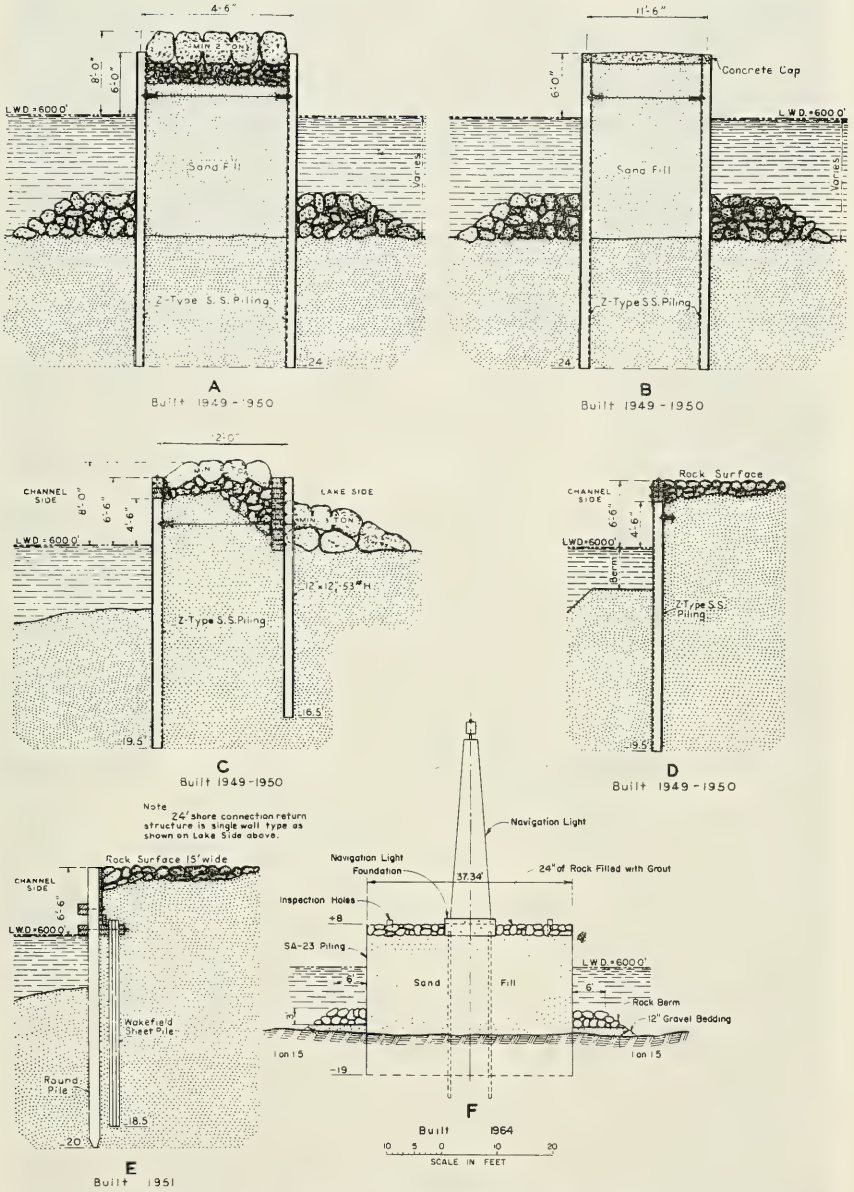
Figure 39. Grand Traverse Bay Harbor, Michigan

1964	Construction of a 164-ft-long north pier extension was completed (Figures 39 and 40, Section F). Cellular steel sheet piles with diameters of 37.3 ft were used. These cells were sand filled with 2-ft-thick rock (filled with grout) caps. The el of the cellular structures was +8 ft lwd, and stone toe protection was installed on the lakeward side.
1975	A 180-ft-long cellular sheet-pile north breakwater extension was completed (Figure 39).
1979	An inspection of the piers indicated that repairs were needed on the cap of the north pier at the intersection of the cell and Section A. Additional repairs were needed on the outer three cell caps.
1981	The north pier caps, identified in need of repair in 1979, were repaired.
1983	An inspection of the structures revealed that the cap on the south pier had settled as much as 6 in. in some areas. The outer cell of the north pier also had settled (up to 14 in.) and had several large cracks. Additional riprap stone also was required at Section C. Repairs to the structures were subsequently made.

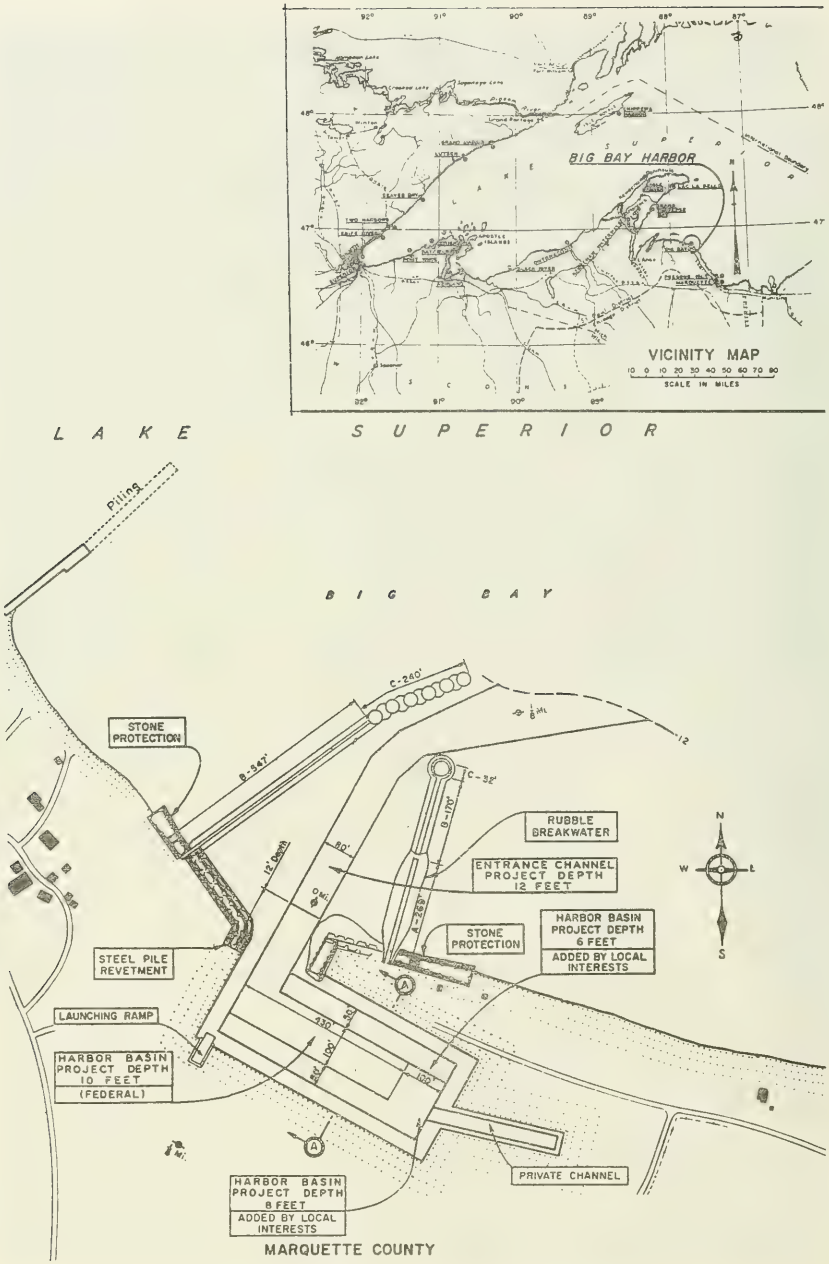
Figure 42. Big Bay Harbor, Michigan

1969	The east breakwater was rehabilitated.
1979	An inspection of the harbor structures indicated that additional riprap was needed on both sides of the west breakwater (Figure 43, Section B). The stone was eventually placed.
1986	The breakwaters presently are in good condition. An aerial view of Big Bay Harbor breakwaters is shown in Figure 44.

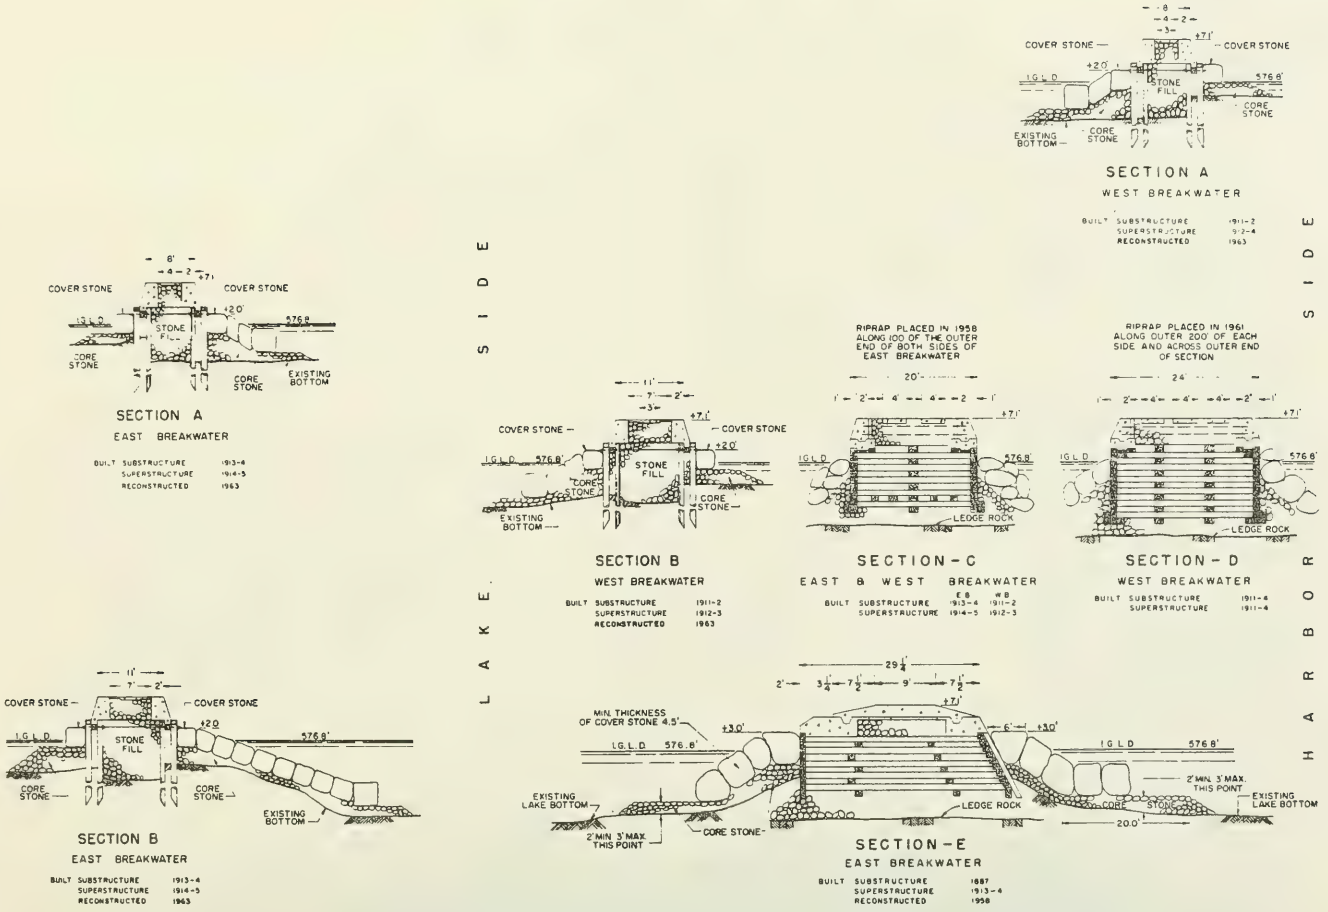
Figure 60. Typical breakwater cross sections, Manistique Harbor, Michigan

1981	An inspection of the breakwaters revealed that the east breakwater had some areas where the concrete cap was in an advanced state of deterioration, and the stone fill had washed away. The west breakwater required some stone fill also and new concrete in some areas. Breakwater repairs were made subsequent to the inspection.
1986	The structures have been reconstructed and repaired during their history and presently are in fair condition.

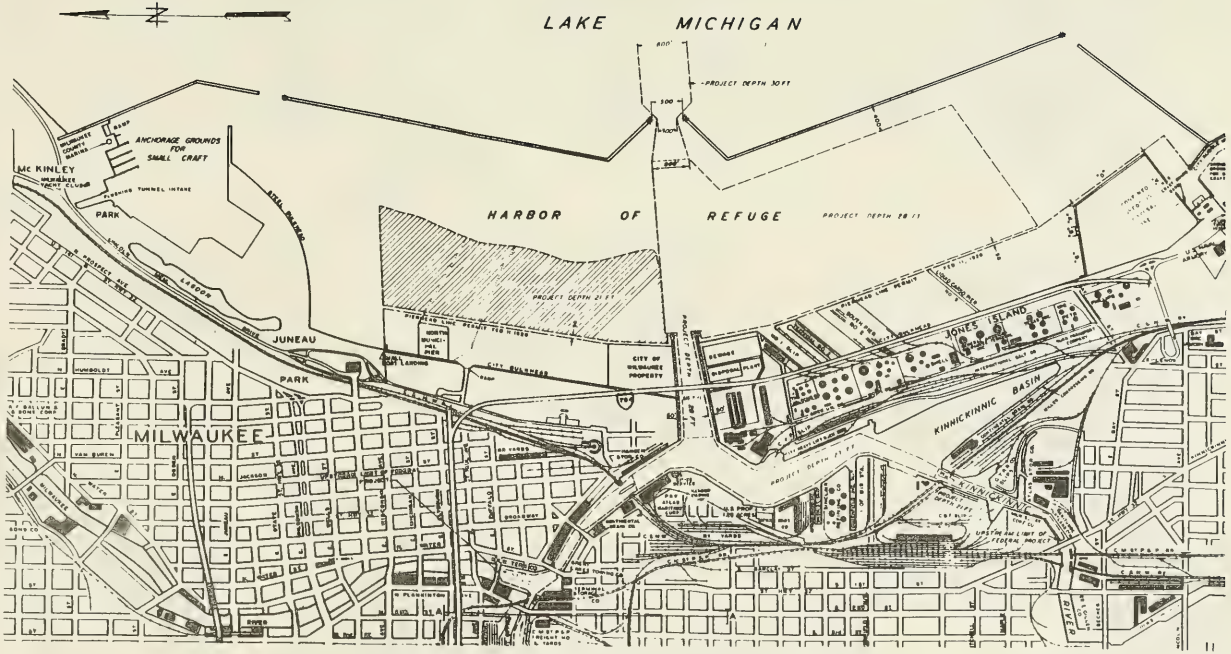
Figure 85. Milwaukee Harbor, Wisconsin

1984	A site inspection of the north breakwater revealed some sections in good shape and others requiring repair and maintenance.
1985	Repair of the head of the south breakwater was completed for a cost of $810,942. A new caisson was constructed and capped with concrete. Stone, ranging from 3 to 6 tons, was placed around the new caisson for toe protection.
1986	The breakwaters and piers are presently considered to be in fair condition.

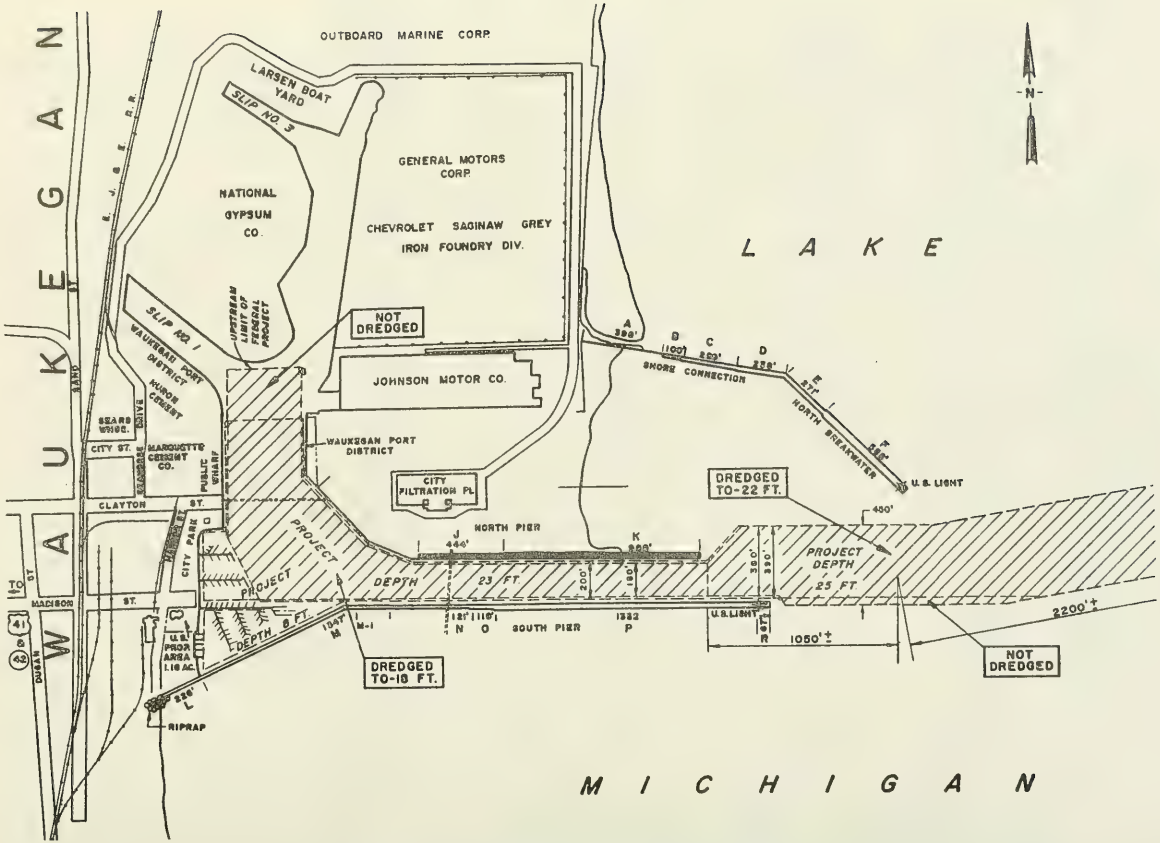
Figure 93. Waukegan Harbor, Illinois

Date(s)	Construction and Rehabilitation History
	+7.1 ft lwd on the channel side (Figure 95, Section K). The south pier superstructure had crest els ranging from +7.6 to 8.85 ft lwd (Figure 94, Sections N, O, P, and R).
1960	A portion of the south pier (Figure 93, Section M-1) was repaired. Steel sheet piles were driven on each side of the existing structure. The voids were filled with stone, and the pier was capped with concrete at an el of +7.85 ft lwd (Figure 94, Section M-1). Stone toe protection was placed on each side of the structure.
1961	The shoreward portion of the north pier (Figure 93, Section J) was removed and rebuilt. Steel sheetpiling was installed at an el of +7.1 ft lwd and backfilled with earth fill (Figure 95, Section J). Riprap toe protection was also installed on the channel side of the pier.
1977	Portions of the south pier (Figure 93, Sections M and O) were rebuilt.
1978	An underwater intersection was made along the north pier which indicated that the structure was intact with the exception of construction joints. There were holes and gaps about 5 in. across at each construction joint along the wall. It was also noted that wood had rotted underneath the concrete cap at several locations. Maintenance repairs were made subsequent to the inspection.

1981	A superstructure condition survey indicated that the structures were in good condition.
1986	The structures have undergone rehabilitation and maintenance during their lifetime; however, they are presently considered to be in good condition. An aerial photograph of the harbor structures is shown in Figure 96.

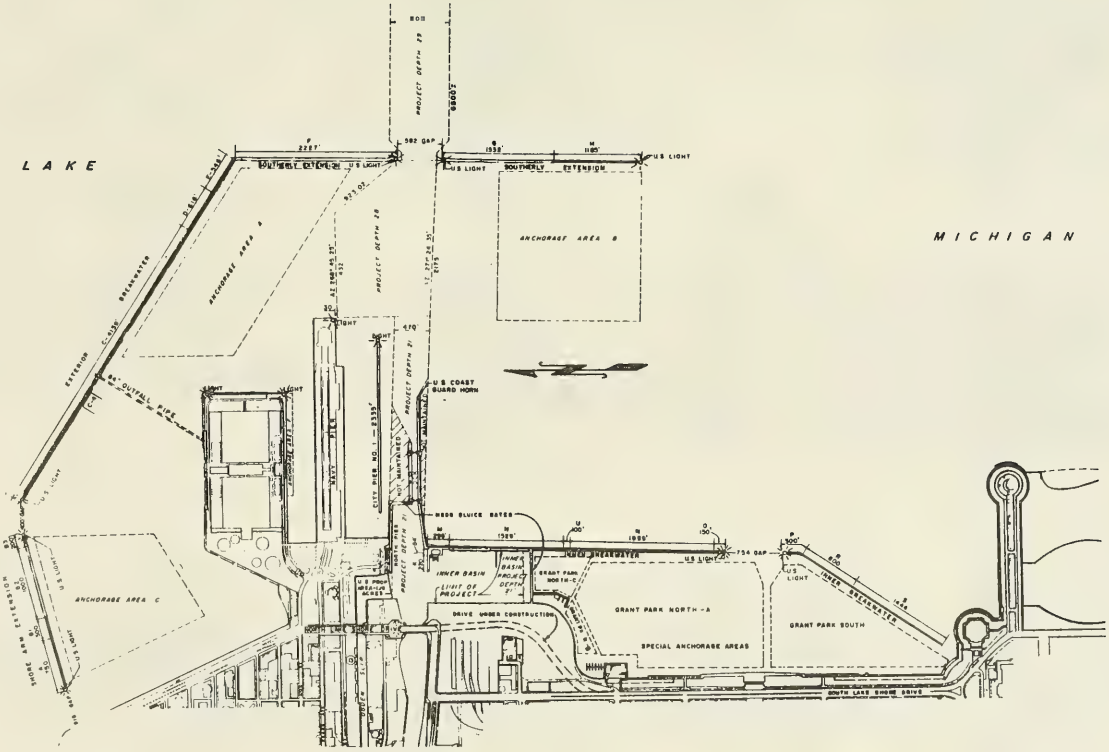
Figure 97. Chicago Harbor, Illinois

1981	A condition survey of the structures indicated that the shore arm extension (Figure 97, Sections A, B1, B2, and B3) were in good condition. The exterior breakwater (Sections C, D, and E) was also in good condition except for an area in Section E where failure of the crib substructure resulted in the superstructure's caving in. The exterior breakwater southerly extension was in good condition at Section H; however, in many locations along Sections F and G concrete fill between the armor stone had been lost. Also, many of the stones were split in pieces and disintegrating. In many locations stone was low (either lost or subsided). The north pier was in good condition except for minor spalling and weathering of concrete. The inner breakwater (Sections K, L, M, N, U, O, P, R, and S) was in good condition except for Sections N, U, and O where the concrete base slab was severely spalled and eroded with reinforcing bars exposed at the edges in many locations.

1983	Rubble-mound areas of the southerly extension (Figure 97, Sections F and G) were rehabilitated, and maintenance of the other faults noted in the condition survey of 1981 was performed.
1986	The structures are presently considered to be in good condition.

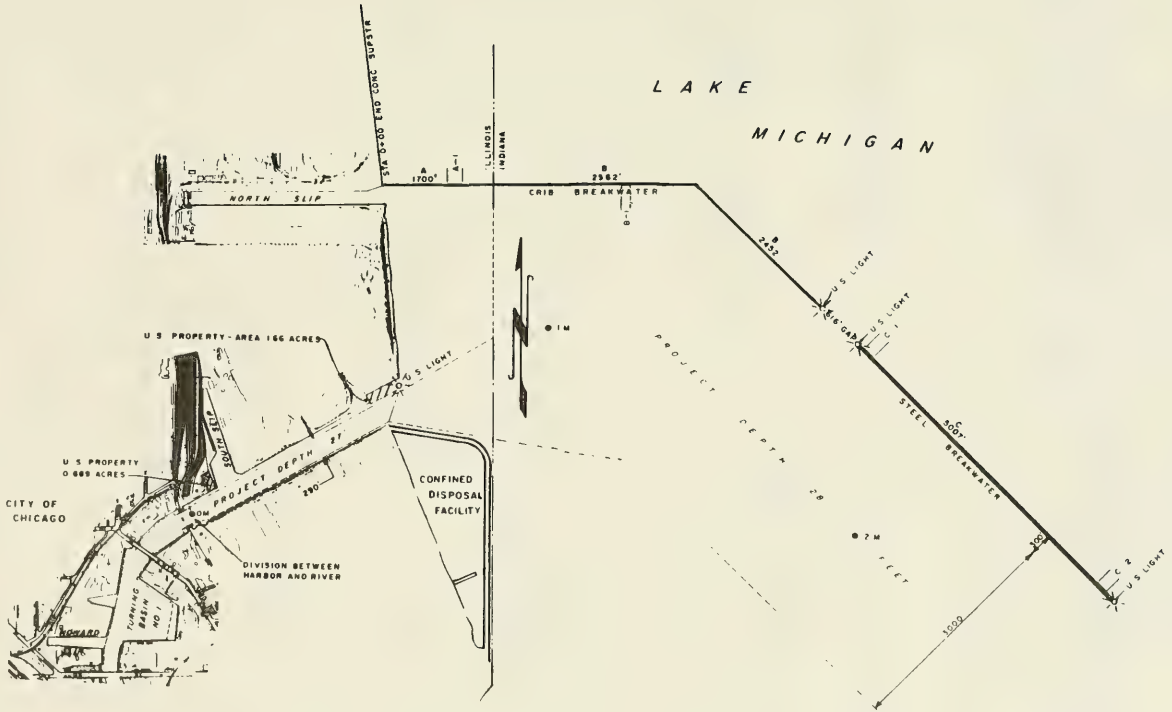
Figure 100. Calumet Harbor, Illinois and Indiana

1957	Portions of the detached breakwater (Figures 100 and 101, Sections C-1 and C-2) were repaired. Heavy riprap stone was placed on each side of the structure at the northern end (Section C-1) and on the lakeside of the breakwater on the southerly end (Section C-2).
1961-1962	Portions of the attached timber crib breakwater (Figures 100 and 101, Sections A-1 and B-1) were repaired. Riprap protection was placed on the lakeside of the breakwater at Section A-1 and on the harbor side at Section B-1.
1984	A severe storm occurred in February with estimated wave heights of 15 ft. Two cells at the southern end of the detached breakwater failed, and the fill stone was lost under the impact of the storm waves. Stones ranging from 6 to 23 tons were placed on the ends of the damaged cells in October to stabilize them and prevent damage to adjacent cells. A total of 3,938 tons of stone was used during these repairs. During November a site inspection of the attached timber crib structure revealed damaged concrete with exposed rebar, spalling, concrete deterioration, fractured concrete, voids, and erosion of some cribs on the harbor side.

1985	A reconnaissance report for breakwater rehabilitation was published by NCC recommending conversion of the attached breakwater to a rubble-mound structure as an attempt to preserve the detached breakwater with rubble-mound berms installed on each side.

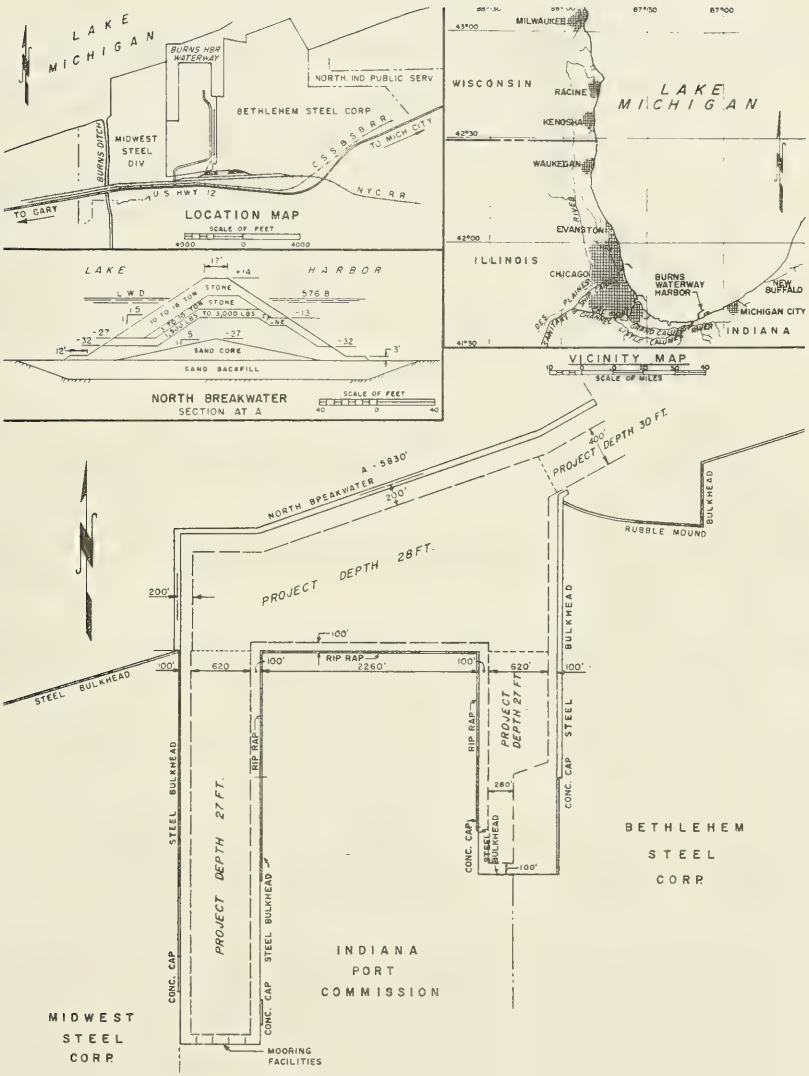
Figure 104. Burns Harbor, Indiana

1978	A total of 14,340 tons of stone ranging from 3 to 16 tons (9-ton average) was placed on the breakwater.
1980	A total of 47,334 tons of stone ranging from 3 to 16 tons (9-ton average) was placed on the breakwater.
1984	A storm in March caused damage to the breakwater dislodging armor stone in many areas and the overall integrity of the above-water stone placement.
1986	The breakwater has undergone extensive maintenance and rehabilitation since its construction because of structure slumping. The exact cause of the slumping is not known. A study is presently being conducted to identify the cause of the problem where remedial measures can be taken.

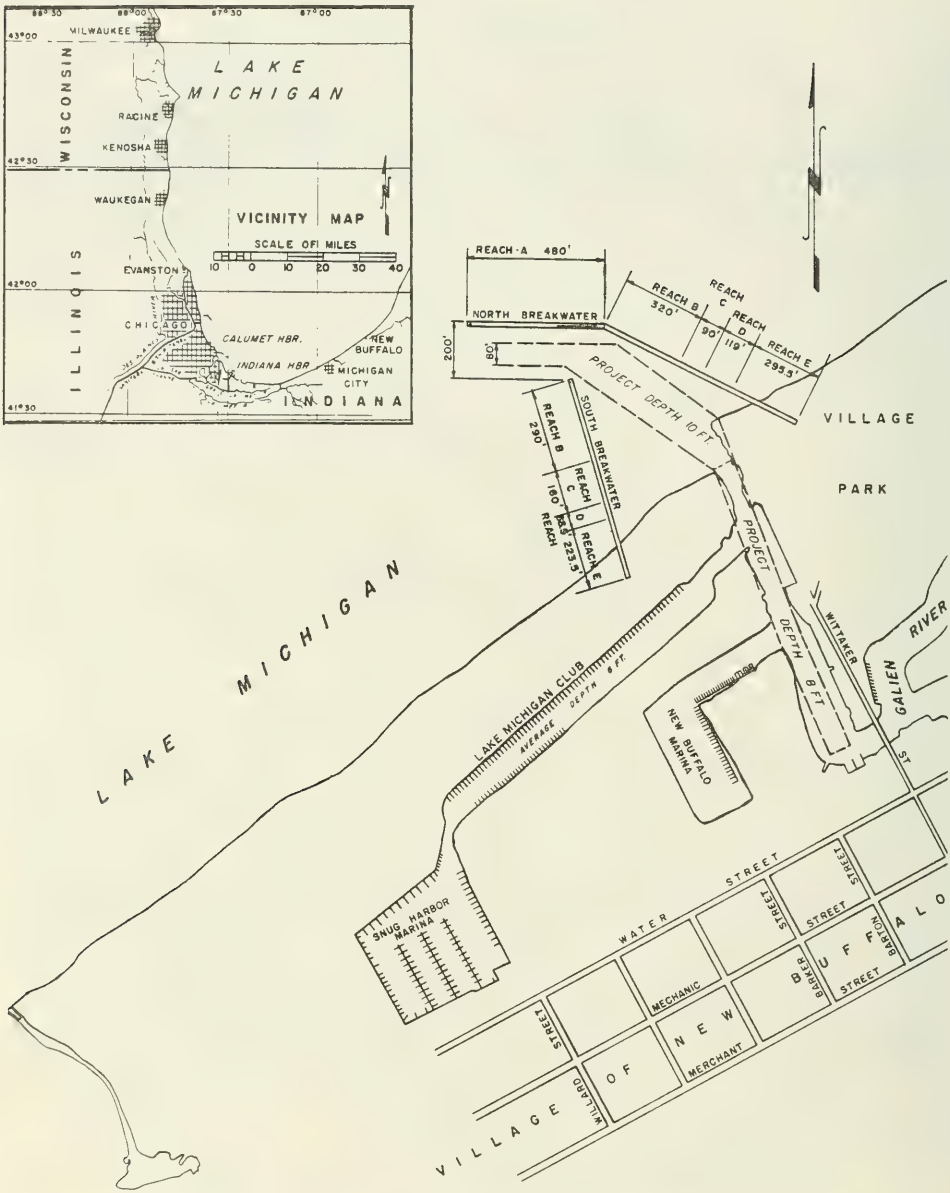
Figure 108. New Buffalo Harbor, Michigan

1980	An inspection of the structures at the site indicated that voids existed in the outer reach (Reach A) of the north breakwater and minor settlement had occurred, particularly around the head of the structure adjacent to the navigation lights. The remaining portion of the rubble-mound north breakwater also consisted of many voids with some stones deteriorating (cracking or crumbling into smaller pieces). The outer portion of the south breakwater (Reaches B and C), although in better condition than the north structure, also had experienced some settlement and contained some gaps where waves washing through the structure was noted. The inner portion of the breakwaters was in good condition.
1983	Stone was placed in the voids of the outer portions of each breakwater (Reaches A and B, north breakwater, and Reach B, south breakwater, Figure 108). A site inspection in the latter part of the year revealed that some of the smaller stone (used to fit the voids) had washed out. Voids in the trunk sections of the breakwater (Reaches C and D, north structure, and Reach C, south structure) still existed along with settlement of 1 to 2 ft in some areas.

1986	The structures are presently considered in fair condition. Maintenance repairs of the breakwater have been recommended but not yet implemented.

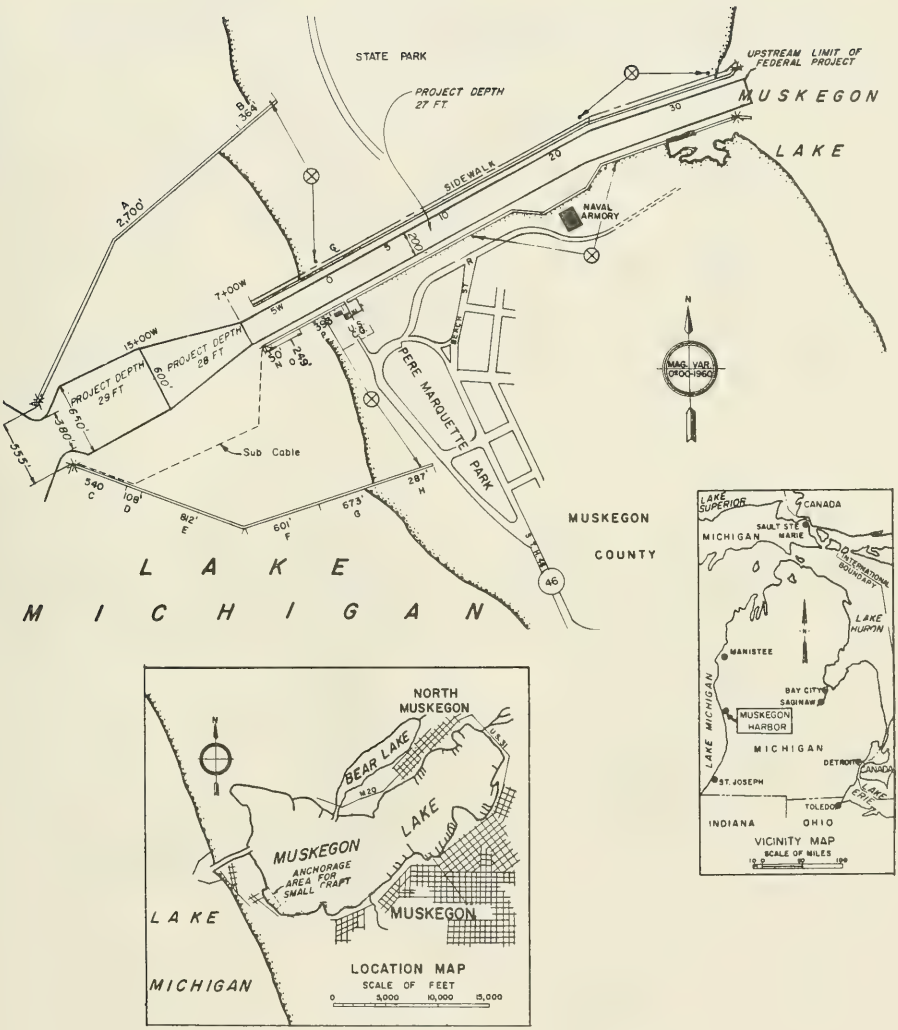
Figure 130. Muskegon Harbor, Michigan

1982	The stone at the head of the west breakwater (Figure 130) again was washed out, and approximately 1020 tons of 8- to 16-ton riprap stone was placed around the navigation light. Also added were 50 tons of 3- to 10-in. fill stone, 247 tons of 50- to 300-lb core stone, and 312 tons of 500-lb to 3-ton riprap to the north breakwater (Figure 130, Section A). Repairs to the head of the south breakwater (Section C) included the addition of 324 tons of 500-lb to 3-ton riprap as core stone along the lakeside face and 1,038 tons of 3- to 16-ton riprap around the breakwater head. In addition, 800 tons of 500-lb to 3-ton riprap stone was placed as toe protection along the channel side of the south pier.
1983	The north pier (Figures 130 and 131) was repaired with the placement of larger cover stone, and 8- to 12-ton riprap stone was placed around the navigation light at the head of the west breakwater (Figure 130).

1984	Major riprap placement at the south breakwater (Figure 130, Sections C, D, and E) for protection against waves and ice action was completed which involved approximately 86,770 tons of 10- to 26-ton cover stone (with stones as large as 49 tons in some areas). This placement encompassed the south breakwater head and both the lake and harbor sides. The stone was placed to an el of +8.0 ft lwd.
1986	Reconstruction of the head of the north breakwater was initiated and involved (Figure 130) removal of the existing cover and core stone and the placement of a steel sheetpiling with a concrete cap breakwater head structure. Also initiated was rehabilitation of the south breakwater concrete caps which are extensively spalled with large pieces cracked and broken off causing a hazard to the public. After these repairs, the structures will be in good condition. An aerial view of Muskegon Harbor structures is shown in Figure 133.

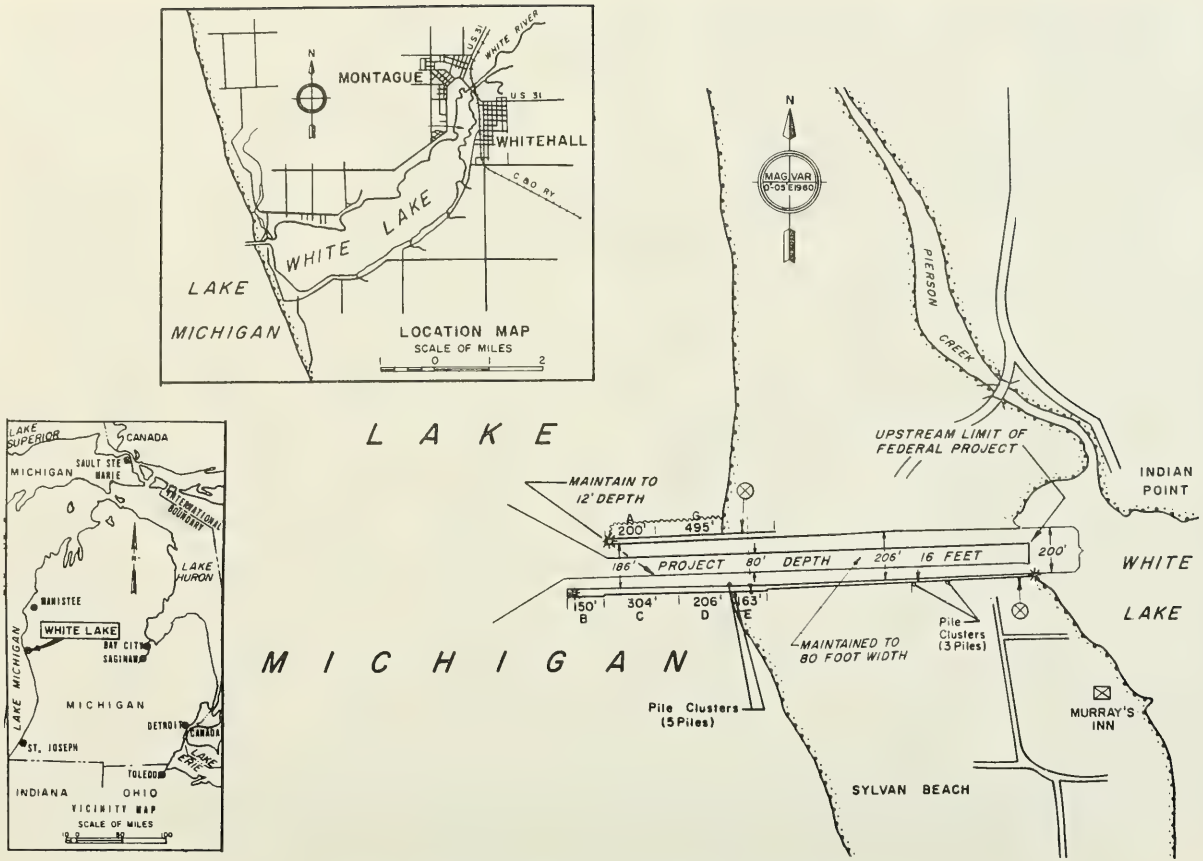
Figure 134. White Lake Harbor, Michigan

1985	An inspection of the structures indicated that the substructures of both piers are deteriorating, resulting in superstructure settlement and cracking, considerable misalignment and tilt, and loss of fill stone. Both structures are considered to be in poor condition. Reconstruction and/or rehabilitation has been recommended within the next 2 to 3 years.
